## DRAINAGE INVESTIGATION AND FLOODING ANALYSIS FOR MALBONE ROAD

PREPARED FOR: Julia Forgue, P.E.  
Director of Utilities  
City of Newport

ORIGINAL DATE: April 2, 2013

PROJECT NUMBER: 401892.DS

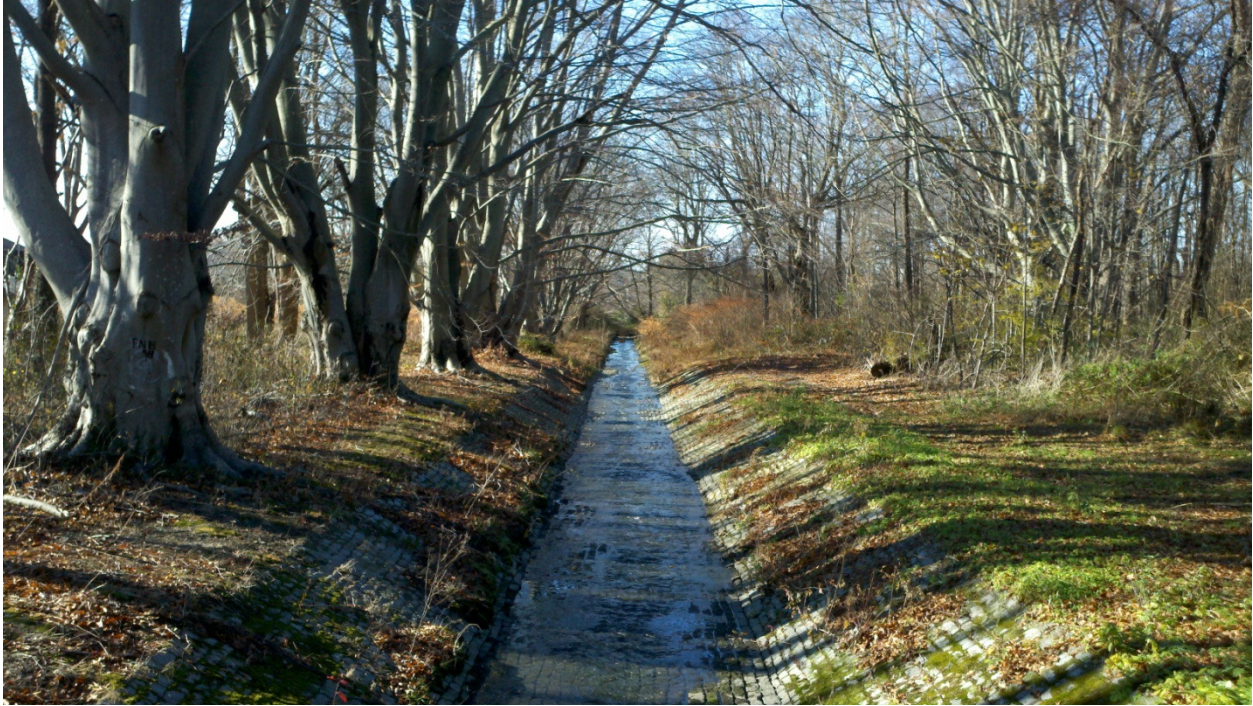
*Photo 1: Malbone Channel - looking west from Malbone Rd.*

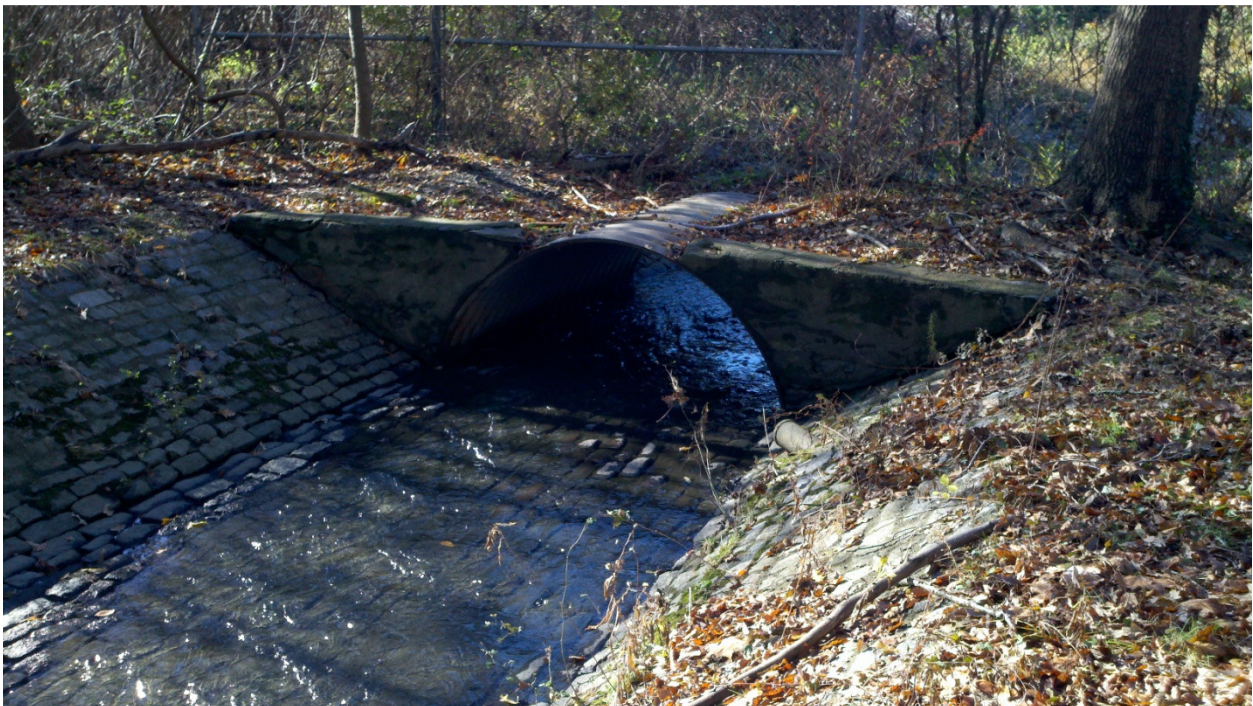
*Photo 2: Malbone Channel - Looking west at culvert approx. mid-point of channel.*

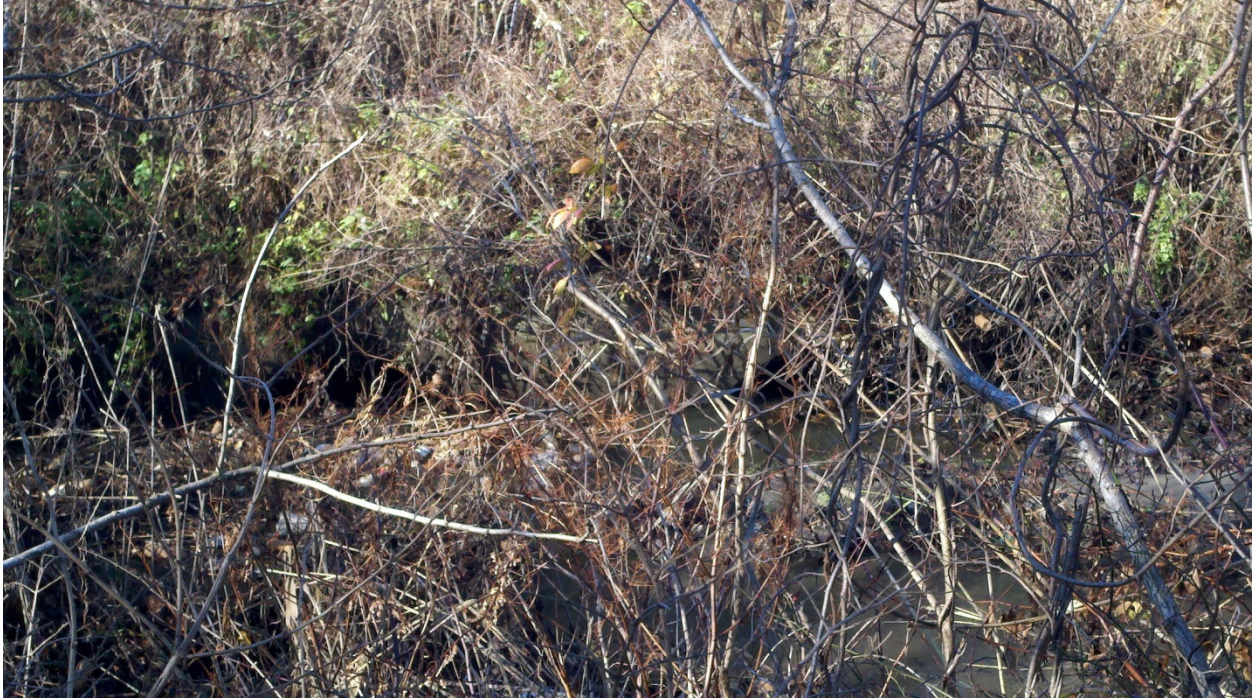
*Photo 3: Double-Barrel Culvert under RI 138/138A/238 – Looking west at City Drainage Swale from rear of DPW Yard.*

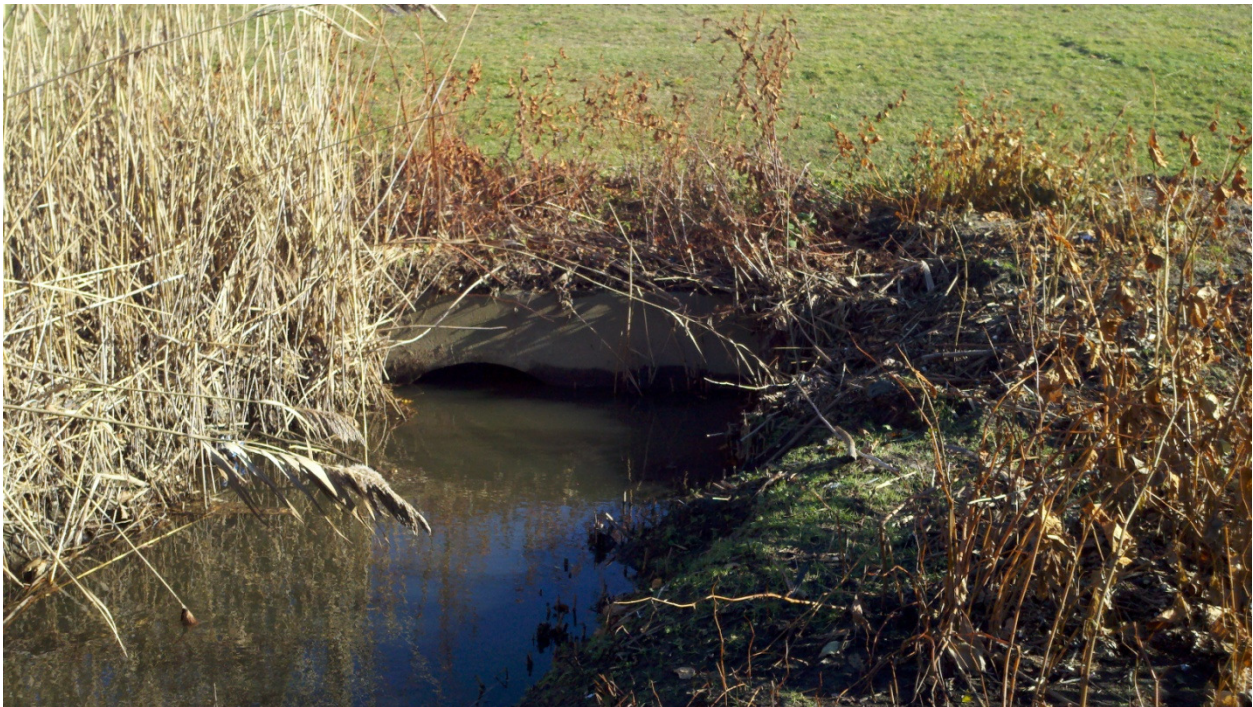
*Photo 4: Outlet of Double-Barrel Culvert under RI 138/138A/238 - Looking east from rear of 111 JT Connell Road.*

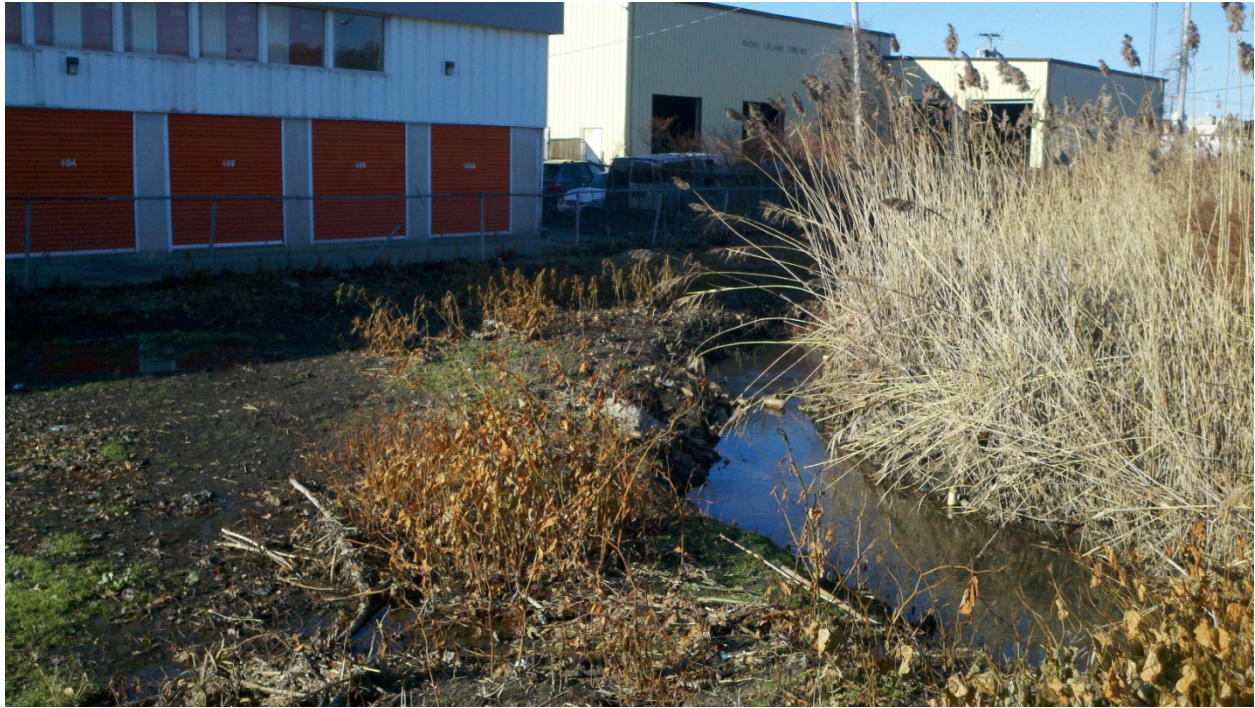
*Photo 5: Drainage swale at rear of 111 JT Connell Rd. - Looking north towards rotary.*

3. Drainage Swale Inspection and Maintenance - CH2M HILL visually observed the existing conditions of the City and State drainage swales downstream of the Malbone Channel from Halsey Street to the rotary at Admiral Kalbfus Road and JT Connell Road. Increased maintenance and cleaning of the swales should be considered due to the quantity of silt, vegetation, and trash observed in the City and State swales. Several photographs taken during the limited walking survey of the drainage system are provided in Attachment 1.

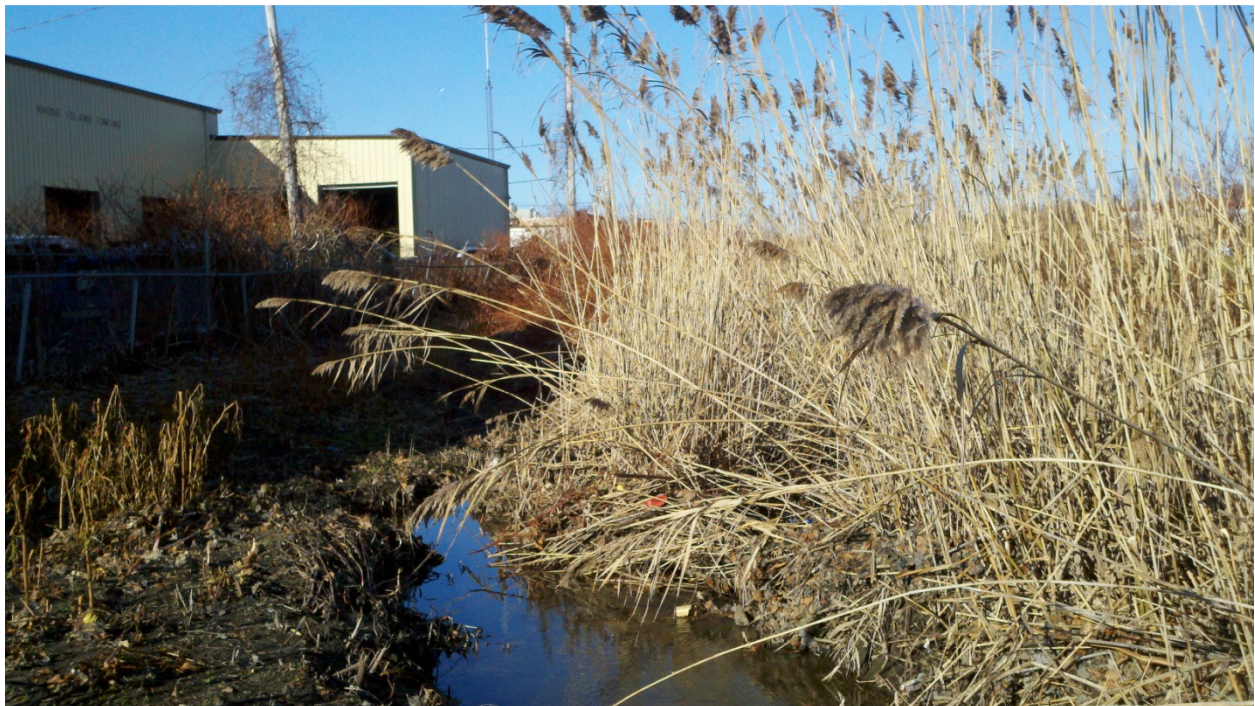
*Photo 6: Drainage swale at rear of 111 JT Connell Rd. - Looking north towards rotary.*

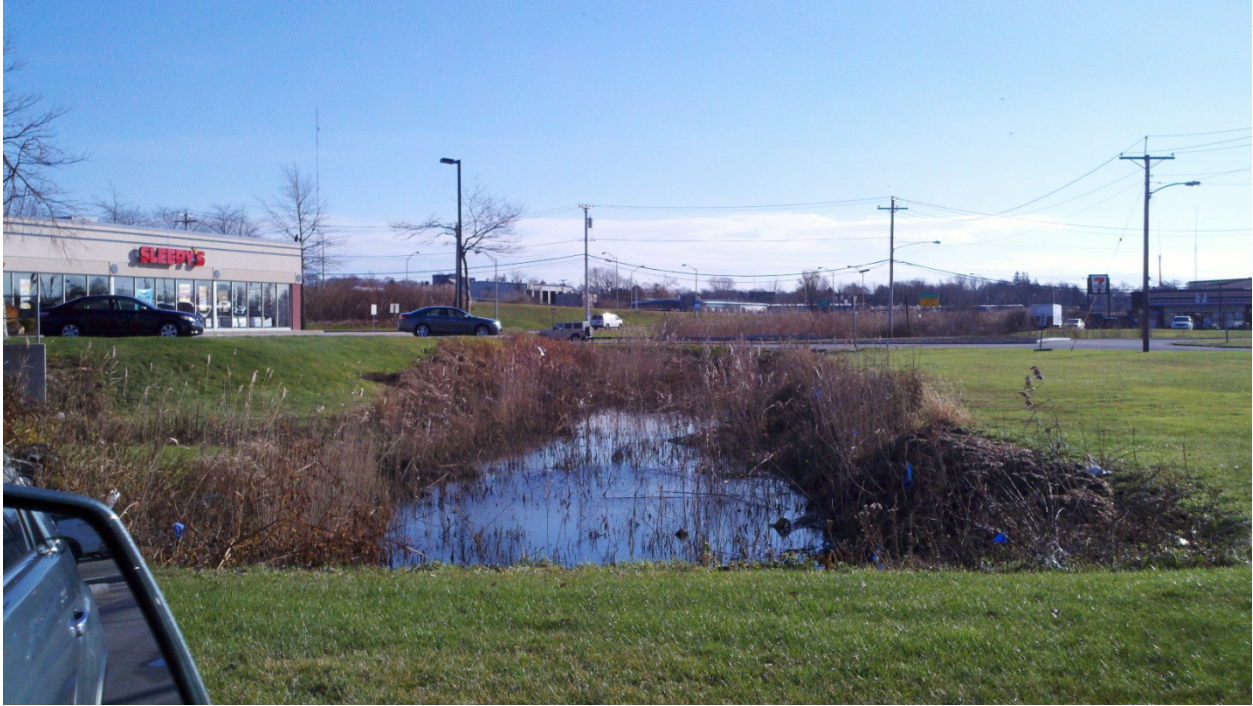
*Photo 7: Drainage swale at Kalbus Way/JT Connell Rotary - Looking south from commercial plaza northeast of rotary.*

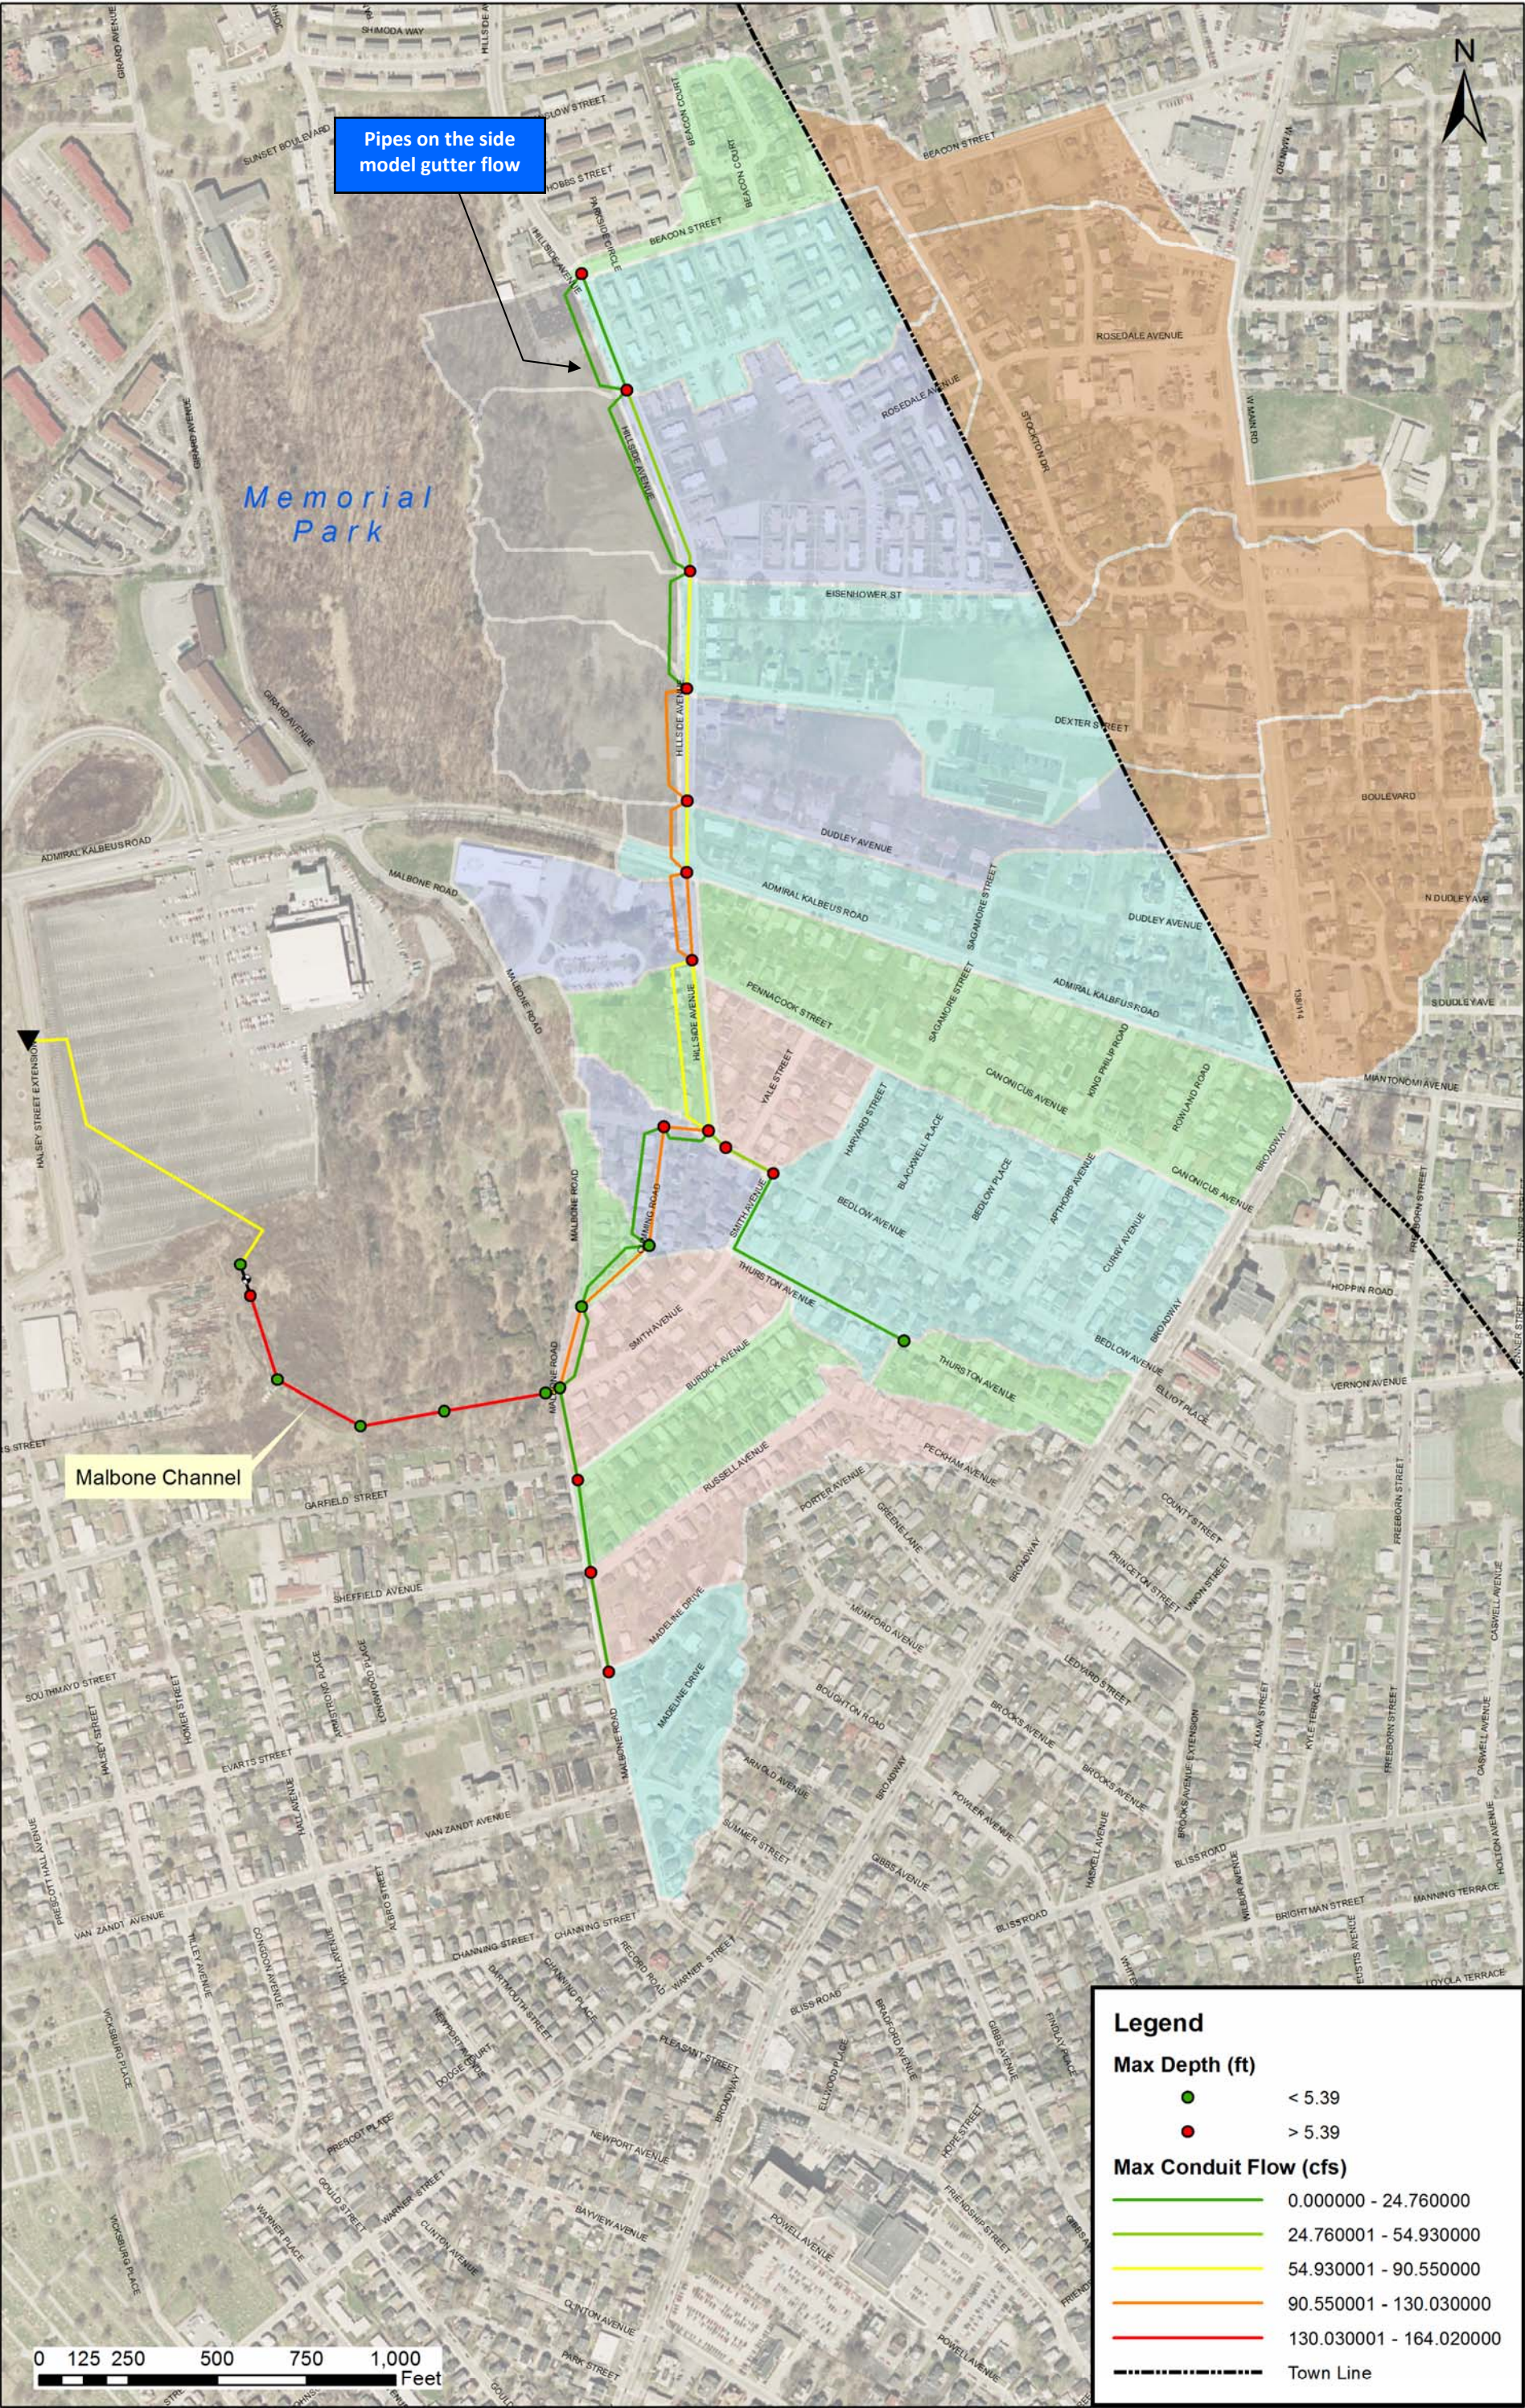
**ATTACHMENT 2: FIGURE 1—MODEL SCHEMATIC**  
**EXISTING CONDITIONS—JULY 28, 2012 STORM EVENT**

**Drainage Analysis and Flood Assessment.** Based on the records reviewed and the field investigation of the study area, the subcatchment areas that were delineated based on LIDAR DEM data were routed to the model network nodes. The model runs were performed to simulate hydrologic/hydraulic conditions during 2012 summer thunder storms that caused substantial flooding of the road way and residential area. Figure 1 of Attachment 2 shows the model schematic network and its peak flood condition during the July 28th storm. When you compare the validation model run results, it matches well with field observation of street ponding and residential lot flooding during that storm for which the flood was wide spread where the downstream end low lying areas (Malbone Street and Cumming Road) experienced the most severe street ponding and flooding in backyards of private property. Table 1 of Attachment 2 summarizes flood location, volume and duration during each of the three storms and for a 10 year type III 6 hour storm. The flood volume in the gutter flow column is an indication of street ponding while gutter overflow is an indication of street runoff overtopping the roadway curbing and running overland and into private property. The model results matched the field observations fairly closely with street ponding occurring during all three storms with the most severe flooding occurred during the July 28th storm and in the low lying areas.

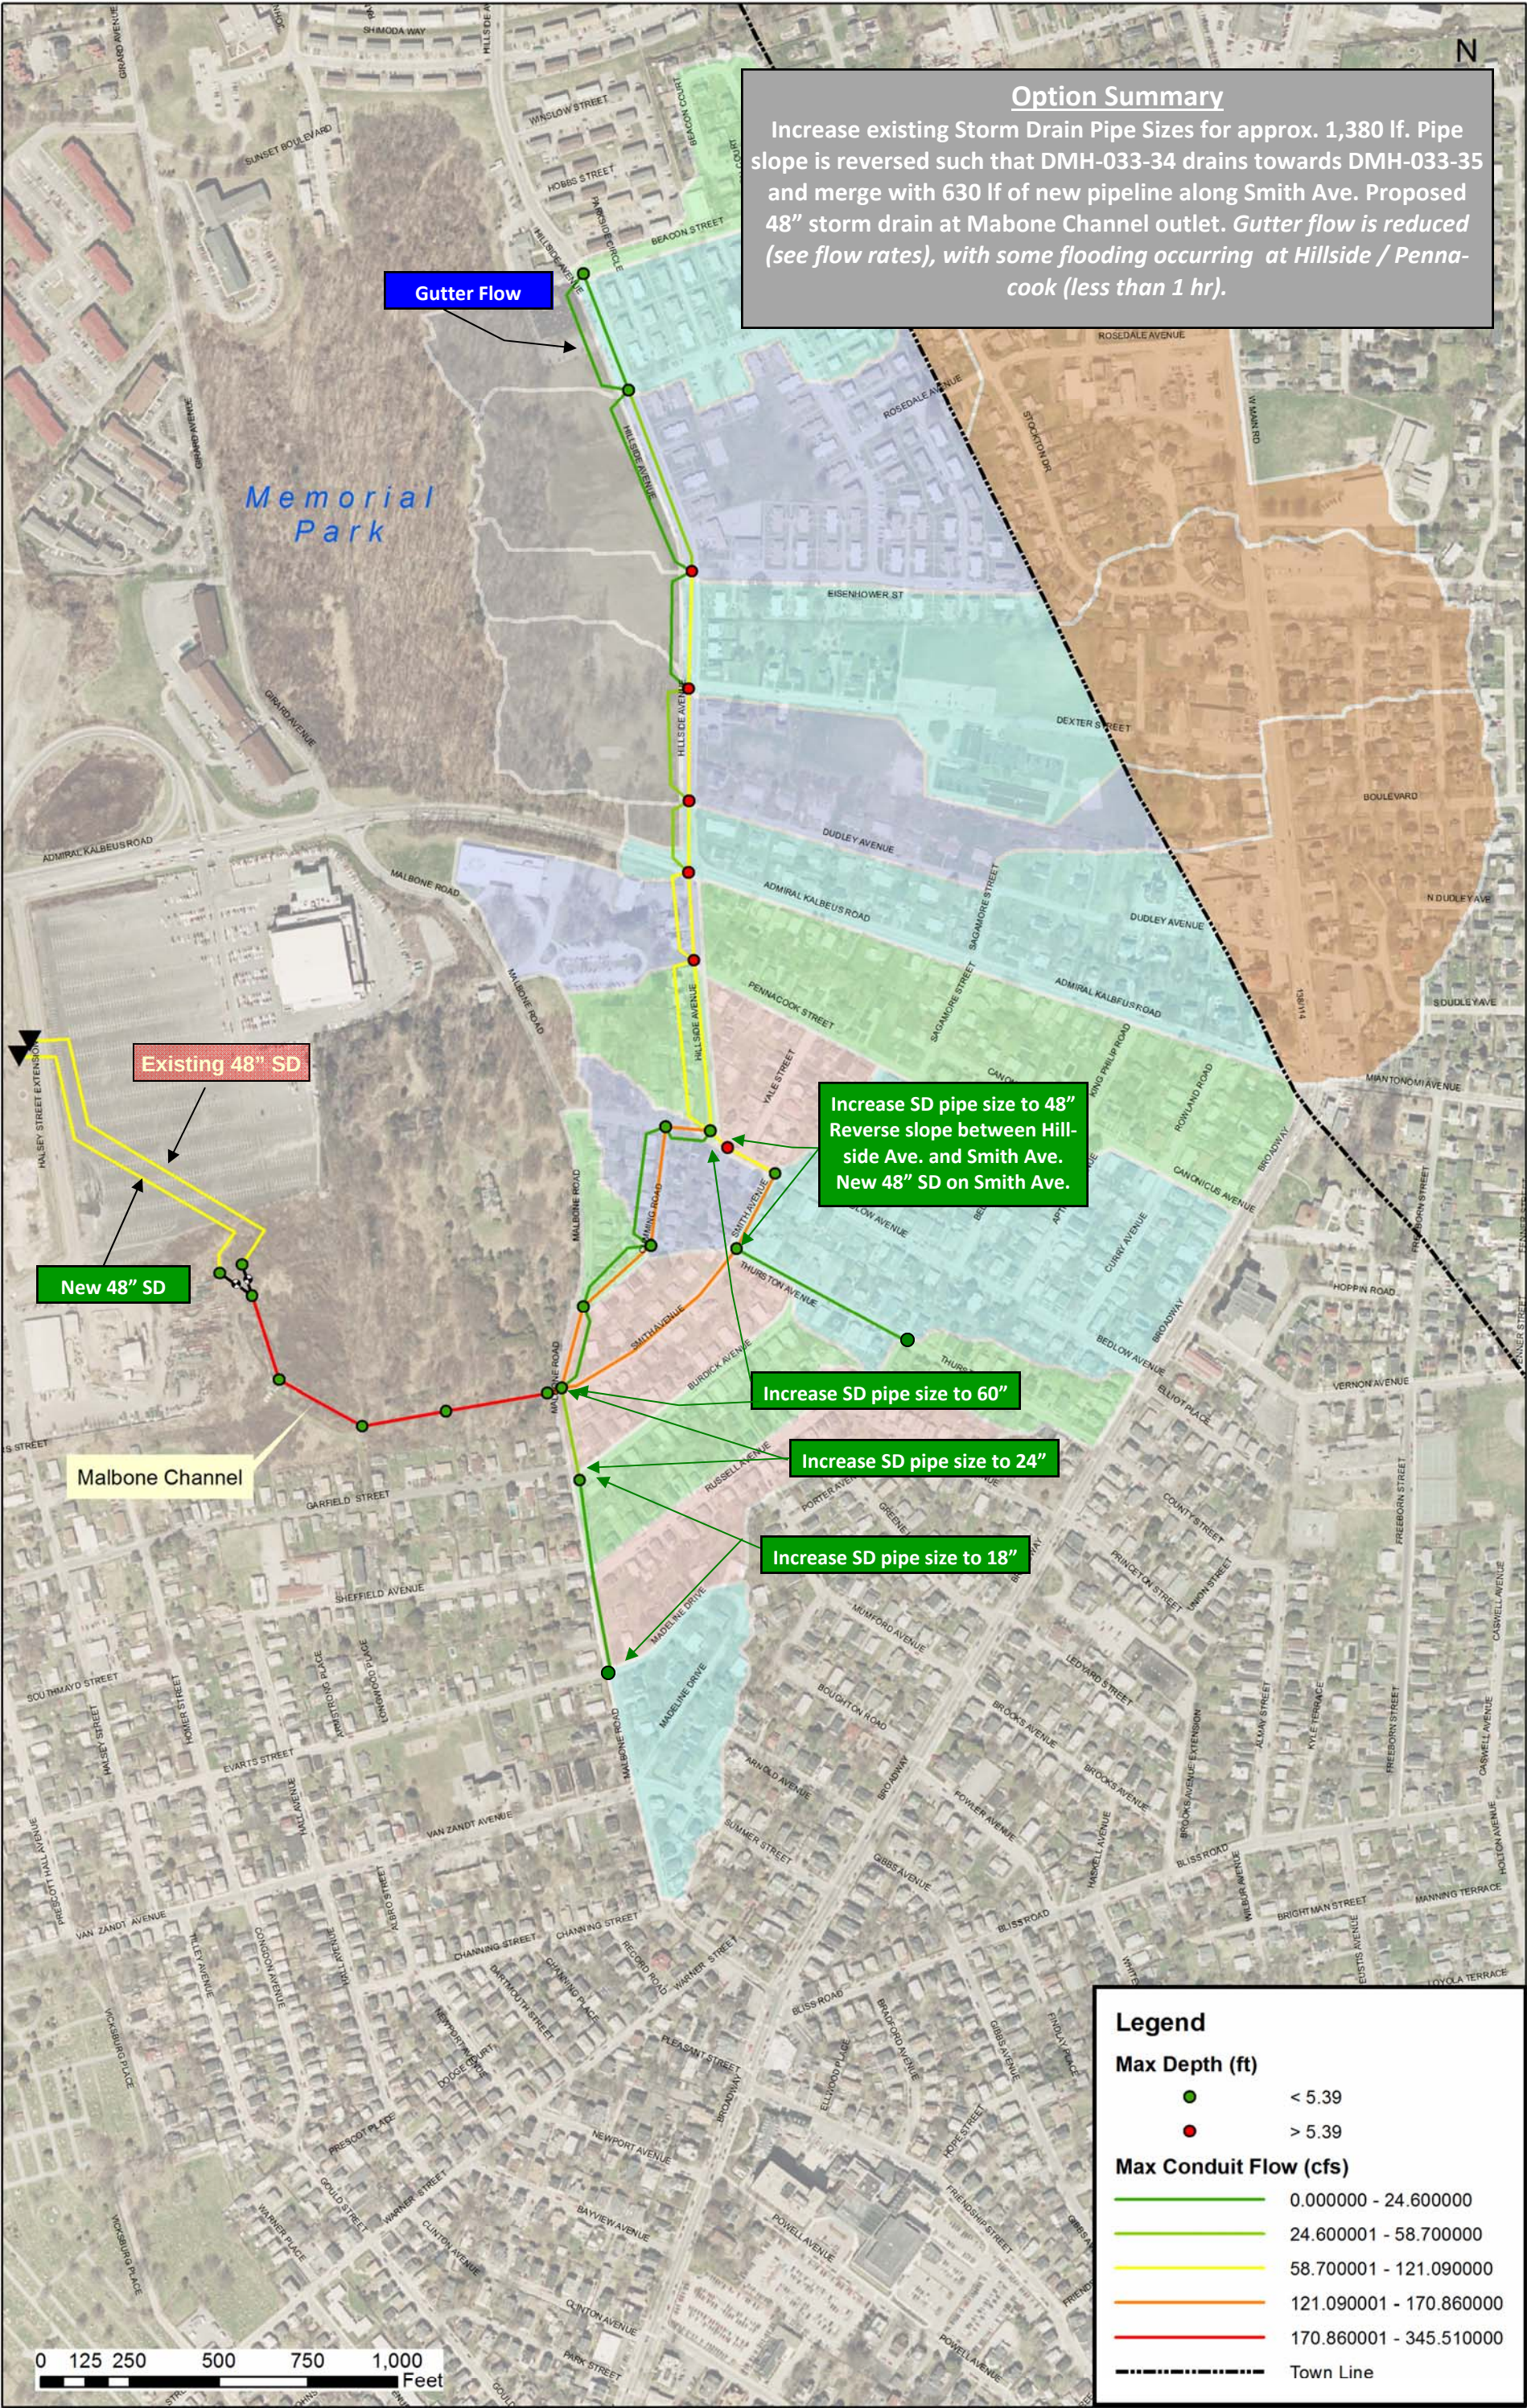
ATTACHMENT 2: FIGURE 4—MODEL SCHEMATIC  
OPTION 2—GRAY CONVEYANCE #2

ponding (short duration, less than 30 minutes, and small volumes) remaining for Options 3 and 4. Although this option improves the drainage conditions, Option 2 alone does not alleviate the flooding issues entirely.

- Local traffic impacts;
- Construction disturbances to residential and commercial areas;
- Potential utility interferences related to increased pipe size and trench width;
- Street flooding still present at intersection of Hillside Avenue and Pennacook Street;
- Gutter flow rates exceeding 75 cfs along Hillside Avenue between Admiral Kalbfus Road and Bedlow Avenue;
- Supplemental drain pipe at Malbone Channel outlet does not provide attenuation of peak flow to levels at or below existing conditions; and
- Potential for easement across casino property.

- Replace approximately 1,380 linear feet of drainage between Malbone Channel and intersection of Hillside Avenue and Bedlow Avenue;
- Existing 12-, 15-, and 18-inch pipe on Malbone Rd proposed increase to 18-inch or 24-inch depending on the segment;
- Existing 36-inch pipe on Hillside Avenue, Bedlow Avenue, Cummings Road, and Malbone Road proposed increase to 60-inch;
- Existing 12-inch pipe on Bedlow Avenue and Smith Avenue increased to 48-inch and slope reversed towards Malbone Road;
- Proposed 48-inch pipe along Smith Avenue to Malbone Road; and
- New 48-inch pipe from Malbone Channel outlet, across the casino parking lot to the drainage swale at the rear of the public works facility on Halsey Street Extension.
