## DRAINAGE INVESTIGATION AND FLOODING ANALYSIS FOR MALBONE ROAD

PREPARED FOR: Julia Forgue, P.E.  
Director of Utilities  
City of Newport

ORIGINAL DATE: April 2, 2013

PROJECT NUMBER: 401892.DS

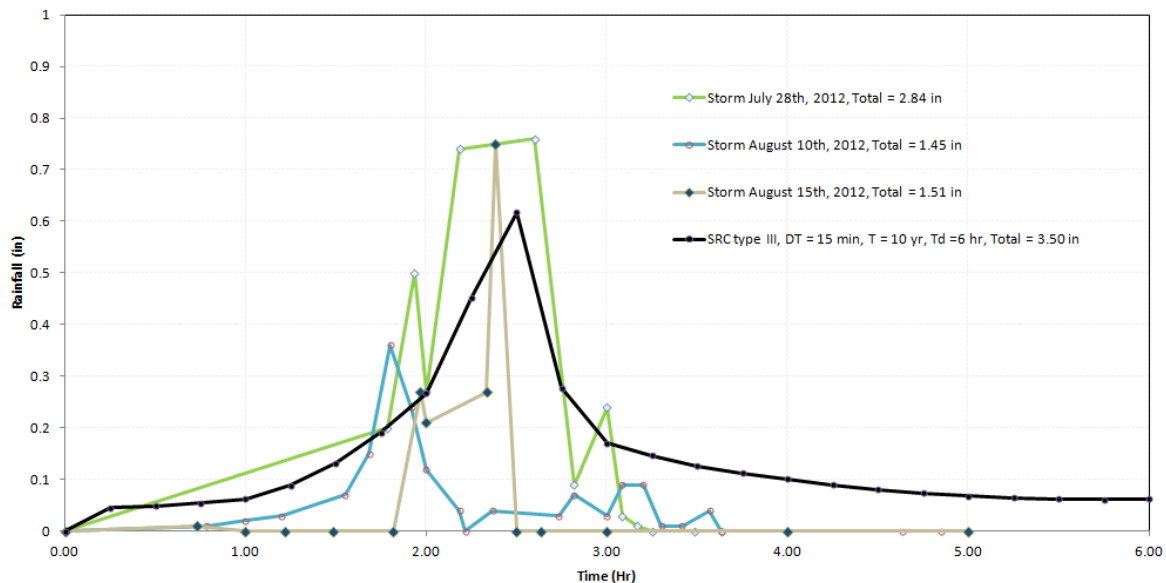
Figure 1 - Hyetograph of the 2012 storms.

below and graphically depicted in the hyetograph, Figure 1, of these storms, which are plotted together with a standard type III storm that are typical in Northeast of United States.

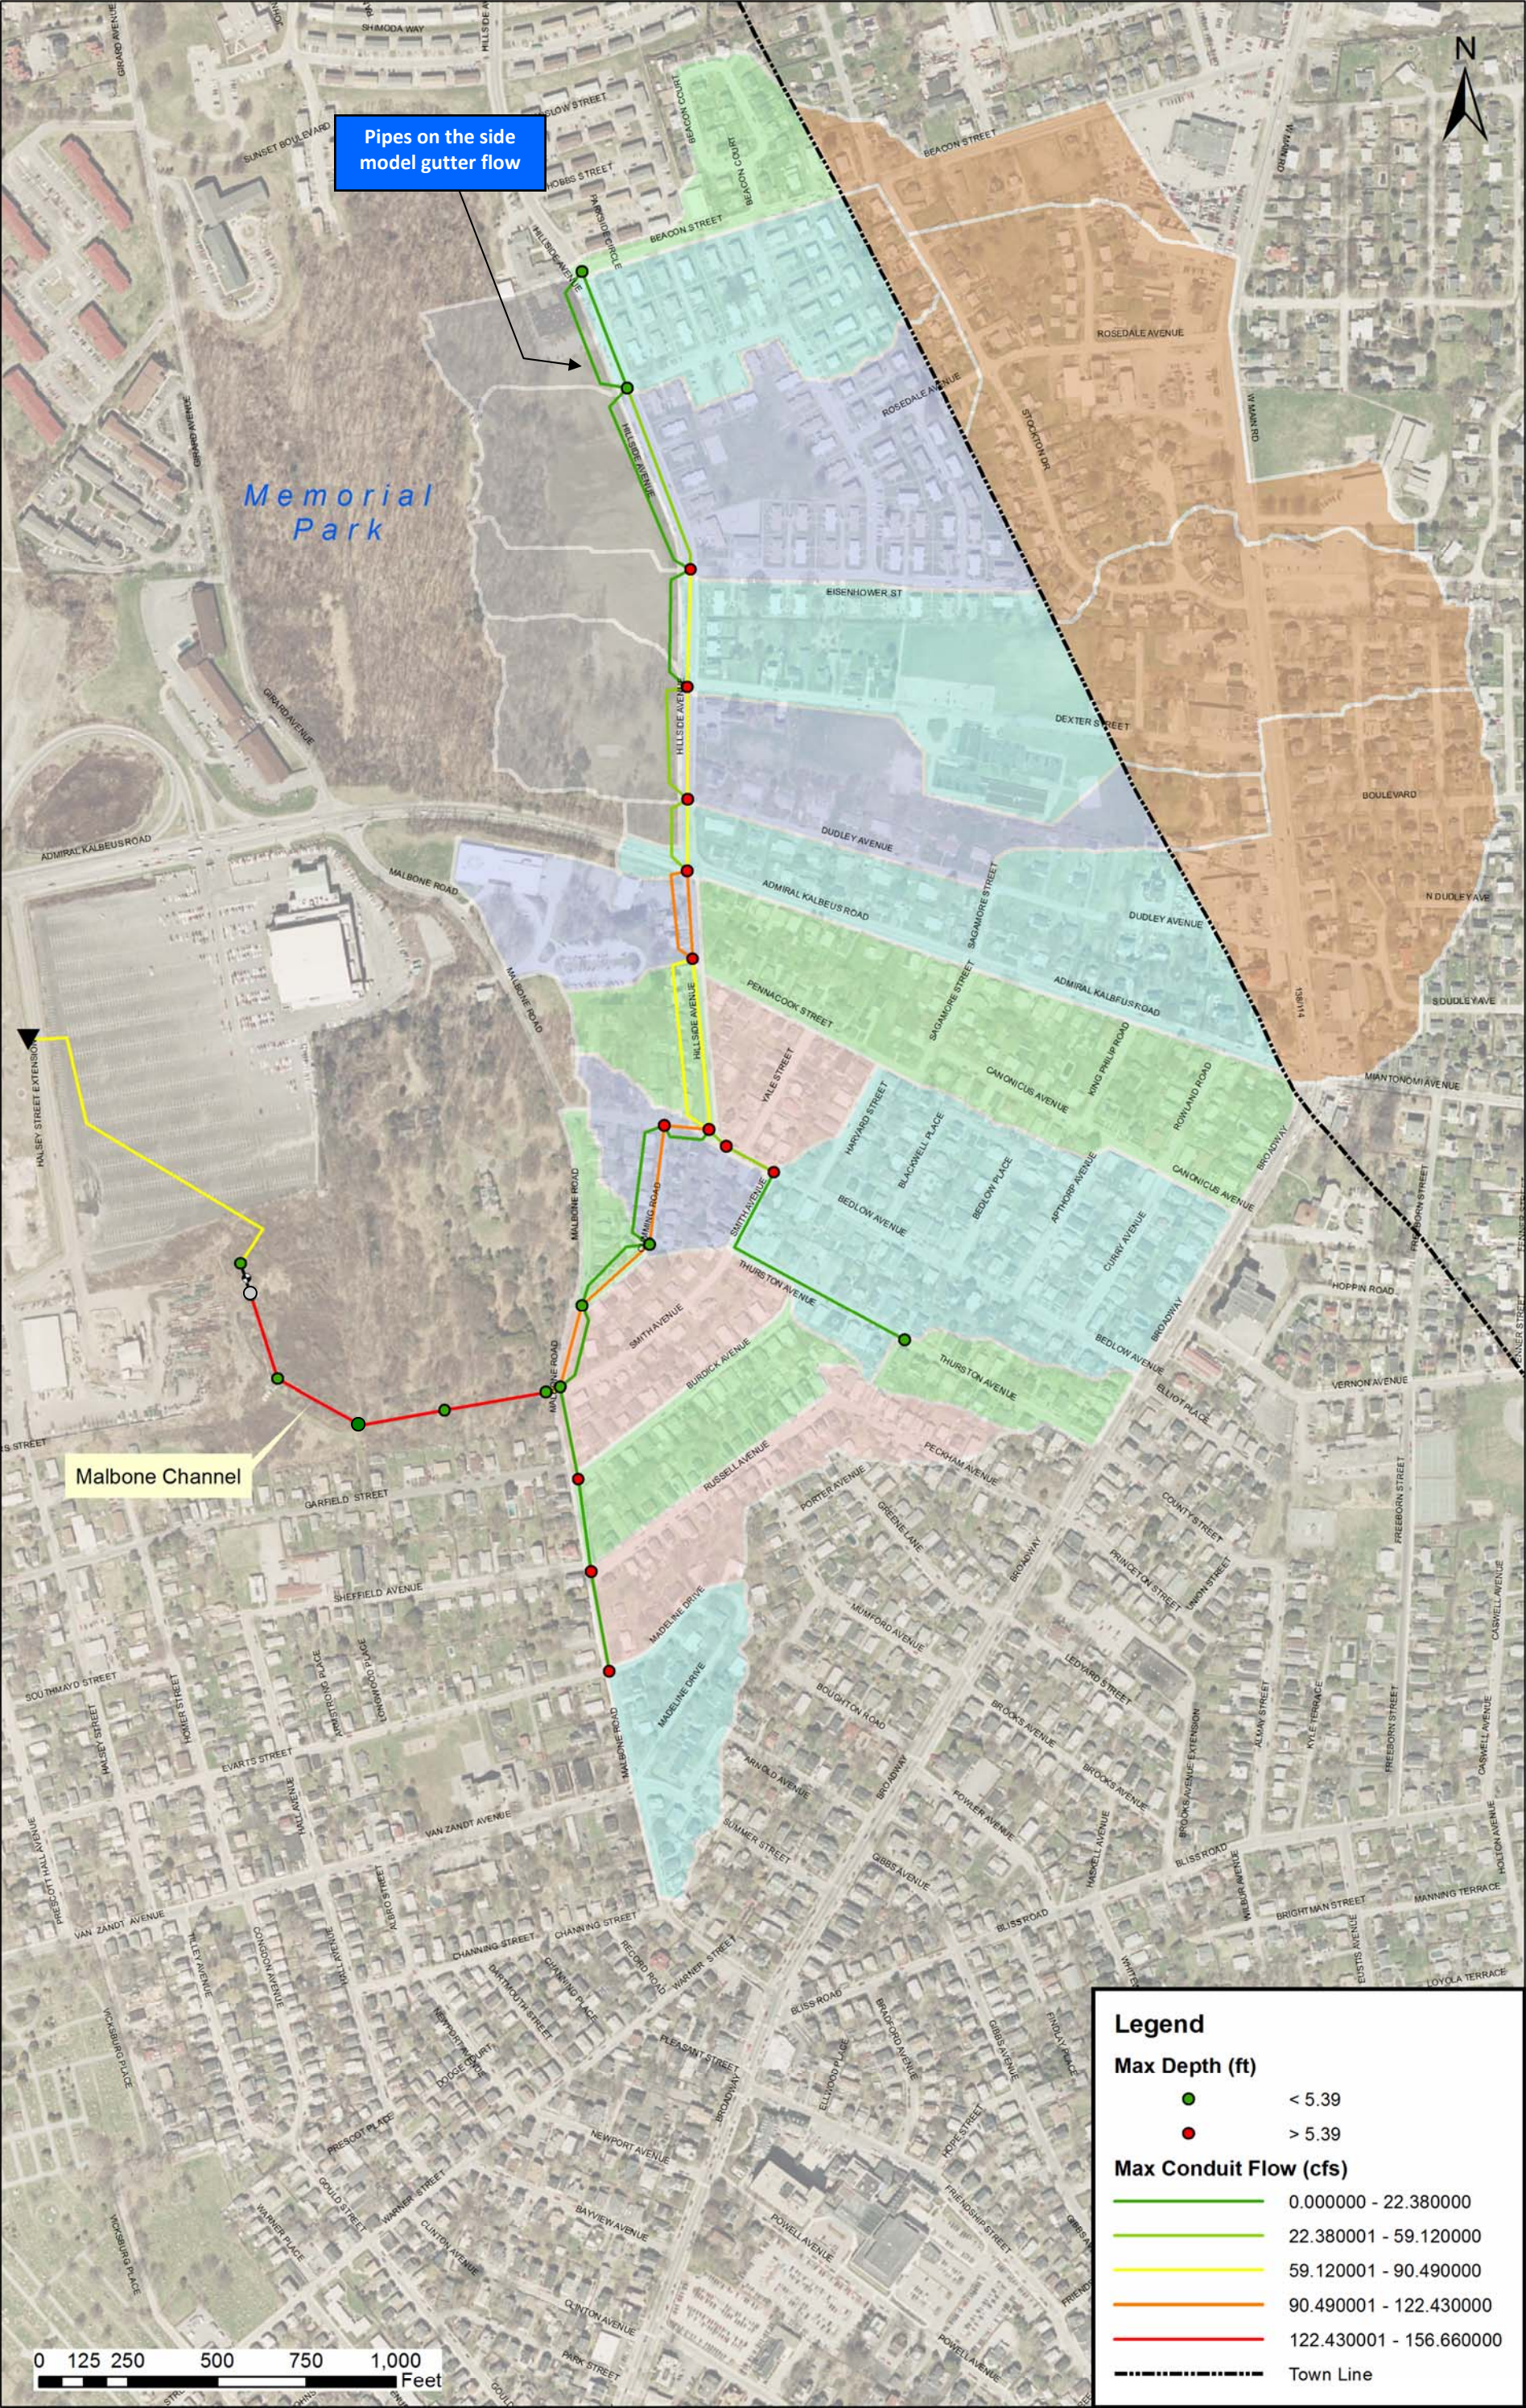
**ATTACHMENT 2: FIGURE 1—MODEL SCHEMATIC**  
**EXISTING CONDITIONS—JULY 28, 2012 STORM EVENT**

**Drainage Analysis and Flood Assessment.** Based on the records reviewed and the field investigation of the study area, the subcatchment areas that were delineated based on LIDAR DEM data were routed to the model network nodes. The model runs were performed to simulate hydrologic/hydraulic conditions during 2012 summer thunder storms that caused substantial flooding of the road way and residential area. Figure 1 of Attachment 2 shows the model schematic network and its peak flood condition during the July 28th storm. When you compare the validation model run results, it matches well with field observation of street ponding and residential lot flooding during that storm for which the flood was wide spread where the downstream end low lying areas (Malbone Street and Cumming Road) experienced the most severe street ponding and flooding in backyards of private property. Table 1 of Attachment 2 summarizes flood location, volume and duration during each of the three storms and for a 10 year type III 6 hour storm. The flood volume in the gutter flow column is an indication of street ponding while gutter overflow is an indication of street runoff overtopping the roadway curbing and running overland and into private property. The model results matched the field observations fairly closely with street ponding occurring during all three storms with the most severe flooding occurred during the July 28th storm and in the low lying areas.
